### Cooling Tower Inspection and repair services

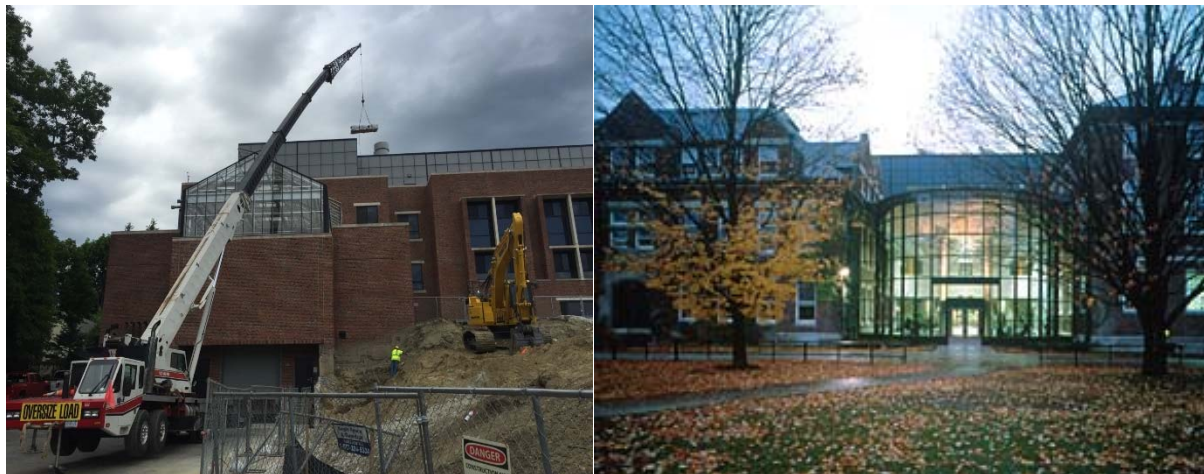
All material and debris were hoisted on/off the roof via mobile crane service. We incorporate a crane lift into a majority of our projects, this significantly cuts down on labor hours.

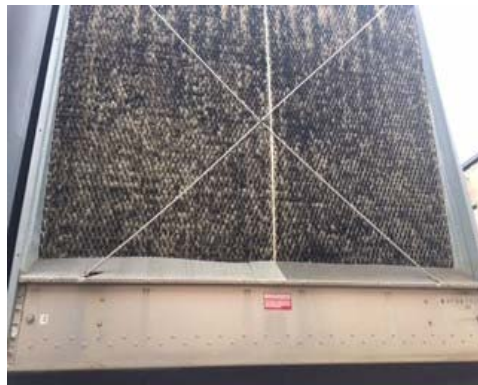
*This is a picture taken prior to the repair. There is a large amount of scaling and debris built up on this fill. Fouled fill can greatly reduce the ability of the cooling tower to transfer heat.*

*Fill was replaced with Marley MX75. MX75 incorporates highly efficient cellular drift eliminators, integrally molded within the fill sheets. The single most important component of a cooling tower is the fill. \*MARLEY MX75 Brochure*
